AIRCRAFT ACCIDENT REPORT

**IN-FLIGHT LOSS OF PROPELLER BLADE
FORCED LANDING, AND COLLISION WITH TERRAIN
ATLANTIC SOUTHEAST AIRLINES, INC., FLIGHT 529
EMBRAER EMB-120RT, N256AS
CARROLLTON, GEORGIA
AUGUST 21, 1995**

**Adopted: November 26, 1996
Notation 6609B**

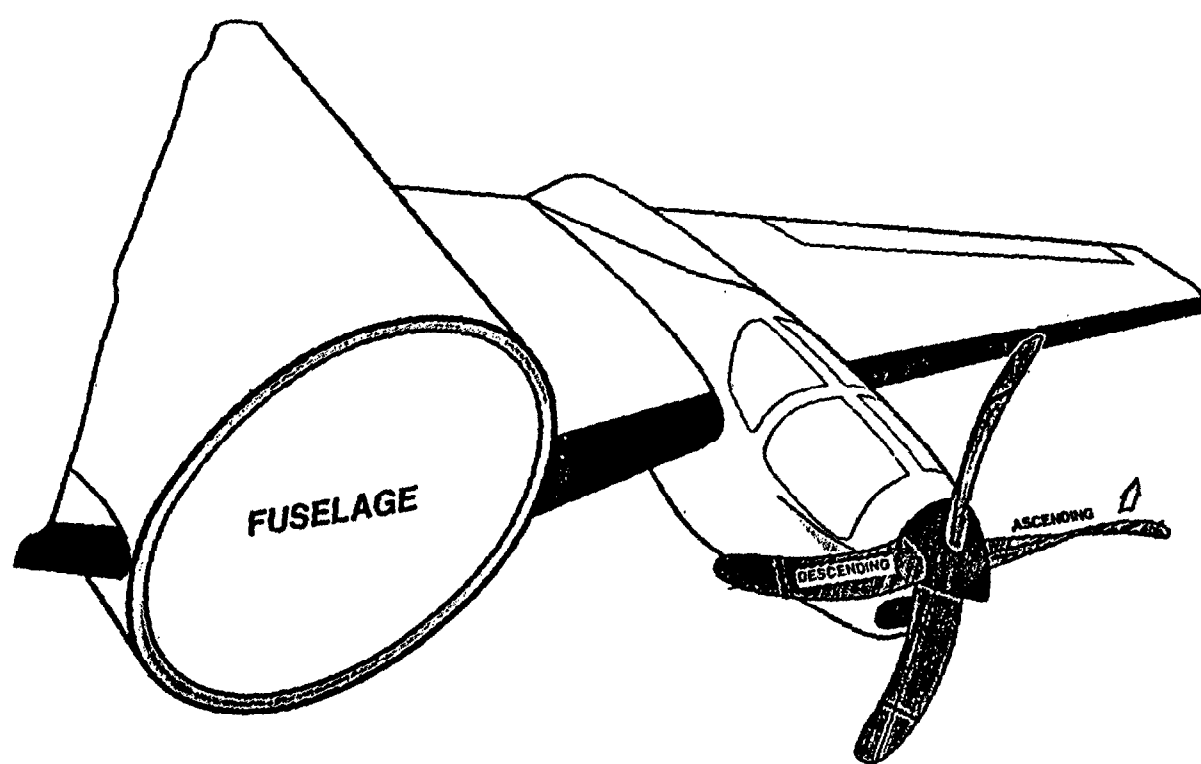
Figure 1.--Propeller installation - left wing.

Investigators found the left engine propeller assembly early in the ground debris path. The propeller hub contained three complete blades and about 1 foot of the inboard end of the fourth blade protruding from the hub. The remainder of the fourth blade was not at the accident site. (See Section 1.12 for more wreckage information.)

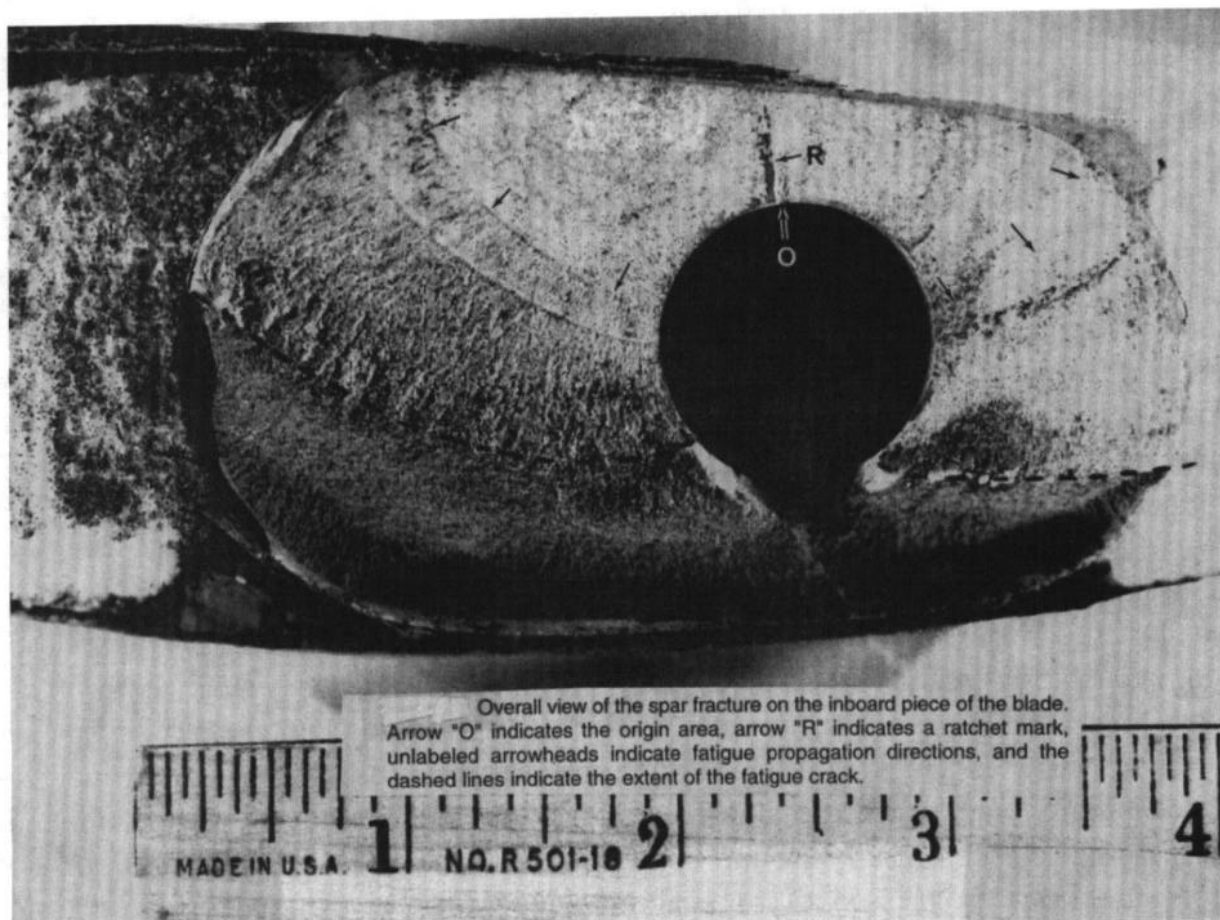
Figure 3.--Photo of the blade fracture surface.

The inboard piece of the fractured blade, serial number 861398, was retained in the left engine propeller hub, which was recovered at the accident scene on August 21, 1995. The outboard piece of the blade was recovered on September 15, 1995, after it was discovered by a farmer on property about 35 miles west of the accident site adjacent to an area that had previously been searched by helicopter. Both portions of the blade were examined at the Safety Board's Materials Laboratory. The blade spar²⁵ was separated at blade station 16.6 (about 13.2 inches outboard of the blade pin platform). Initial visual examination revealed that a portion of the spar fracture was on a flat transverse plane and contained crack arrest positions, typical of fatigue cracking (see Figure 3). The fatigue cracking appeared to initiate from at least two adjacent locations on the taper bore surface. Below the taper bore surface, the individual cracks joined to form a single crack that propagated toward the face side²⁶ of the blade and progressed circumferentially around both sides of the taper bore. The extent of the fatigue cracking progressed through about 75 percent of the spar cross section. The fracture surface in areas beyond the terminus of the fatigue region contained rough features with a matte appearance, typical of an overstress separation area.

The origin areas on both the inboard and outboard faces of the fracture were examined with a scanning electron microscope (SEM) before the faces of the fracture were cleaned. The fracture surface near the origin area on both faces of the fracture contained a layer of heavy oxide deposits that had a mud-cracked appearance. These deposits extended to a maximum depth of 0.049 inch from the taper bore surface. Their maximum circumferential width was 0.130 inch, based on the examination of the damaged outboard fracture face. X-ray energy dispersive spectroscopy (EDS) of the deposits of both faces generated similar spectra with a major peak for aluminum, a substantial peak for oxygen, and a minor peak for zinc.²⁷ EDS of the deposit area on the inboard fracture face also revealed the presence of chlorine.

After the fracture surface had been cleaned, additional SEM examination revealed that the fatigue cracking initiated from several corrosion pits in a line of pits in the taper bore that extended over a distance of about 0.070 inch. The maximum depth of the corrosion pitting at the fatigue origin area was measured as slightly less than 0.006 inch below the taper bore surface.

The taper bore surface, including the area adjacent to the fatigue initiation area, contained a series of nearly circumferential sanding marks. The marks extended over about 180 degrees of the circumference of the taper bore and to a maximum distance of about 1.5 inches inboard of the fracture surface. Outboard of the fracture, the sanding marks extended about 2 inches from the fracture surface.

The investigation revealed that sanding rework of the area had been accomplished using the blending repair procedures contained in PS960A.²⁸ The procedures required that the surface finish of the blended area should be restored to the original surface finish. Postaccident surface profilometer measurements conducted on the taper bore sanding marks indicated that the surface finish was much rougher than the manufactured surface not disturbed by the rework process.²⁹ Measurements also indicated that the nondisturbed surface met the manufacturing specifications.

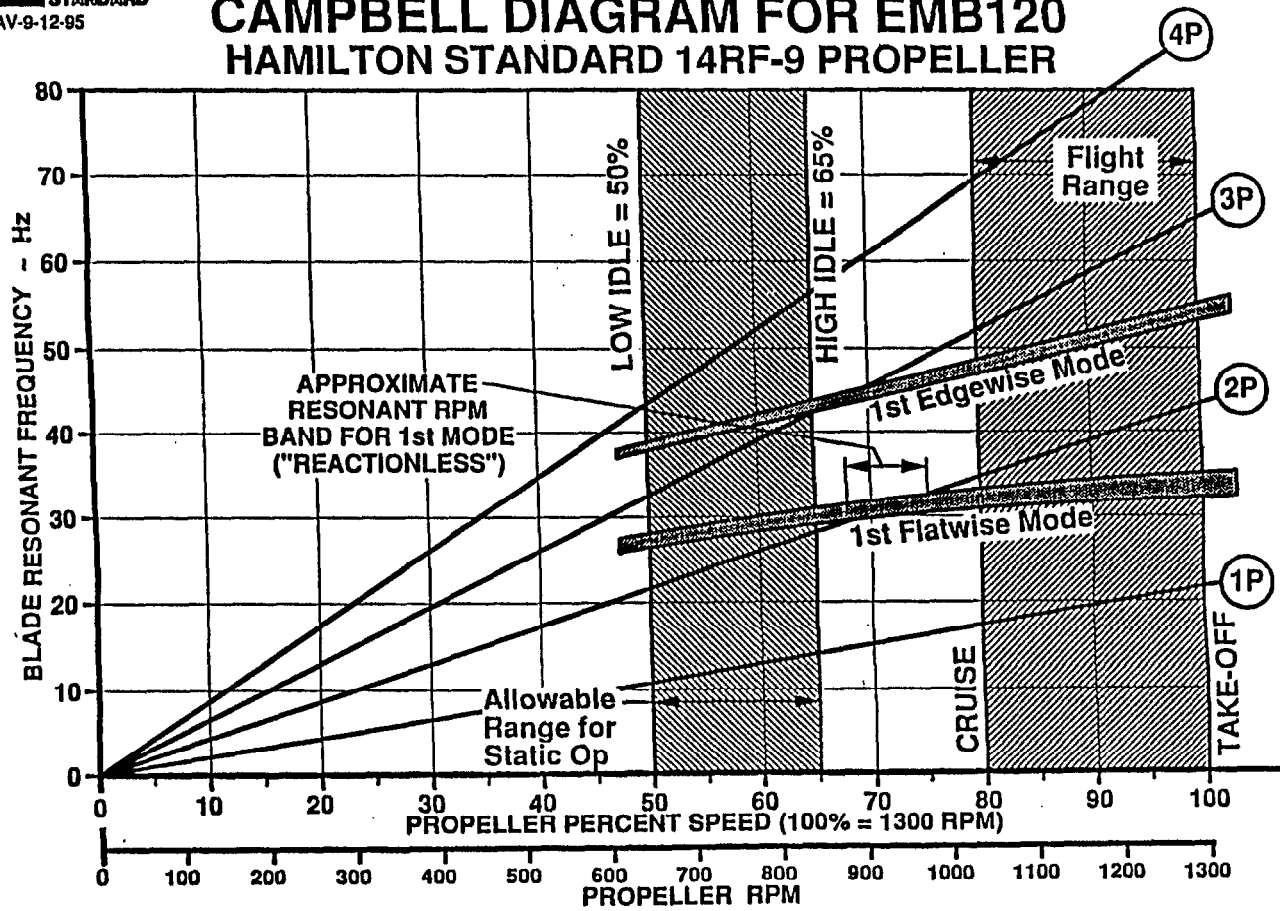
Figure 4.--Vibratory modes of the 14RF-9 propeller.

When the first flat-wise vibration frequency and the 2P excitation frequency coincide, a four-bladed propeller, such as the 14RF-9, vibrates in the reactionless⁴⁹ mode. The reactionless mode of vibration is characterized as when two blades of a four-bladed, rotating propeller, 180 degrees apart, reach a negative stress peak at the same time that the other two blades reach their positive stress peak. This type of propeller vibration is called reactionless because the bending loads of the four blades are canceled at the propeller hub which consequently transmits little or no vibratory loading to the propeller mounting structure.
